Flood Mitigation Strategies in Rajabasa Subdistrict, Bandar Lampung and Analysis of On-Site Flood Conditions

Flooding in Rajabasa Subdistrict, Bandar Lampung City, is a recurring urban disaster that intensifies during periods of high rainfall. This study aims to identify the dominant causes of flooding and to formulate appropriate mitigation strategies based on spatial analysis, community interviews, and hydrological modeling. The research employed Geographic Information System (GIS)-based spatial analysis, field observations, structured interviews with affected residents, and hydrodynamic simulations using the HEC-RAS model to evaluate drainage capacity and flow behavior. The results indicate that flooding is primarily caused by inadequate drainage systems, uncontrolled land-use conversion that reduces infiltration areas, and sediment and waste accumulation within drainage channels. Spatial analysis reveals that flood-prone zones are concentrated in low-lying, densely populated areas with flat topography and poor drainage conditions. Based on these findings, mitigation strategies emphasizing drainage normalization, infiltration enhancement, riverbank vegetation, and community-bas

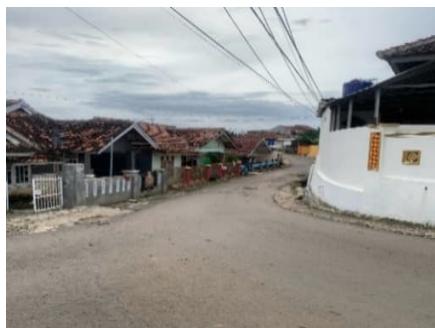
1. **Gang Ibrahim** (Rajabasa Induk Subdistrict): Ibrahim Alley, located in Rajabasa Induk Subdistrict, is one of the most frequently flooded areas in Rajabasa. The neighborhood lies on lowland terrain with dense residential settlements. The drainage system is narrow and often clogged by sediment and domestic waste, causing water to overflow during periods of heavy rainfall. In the most recent flooding event, approximately thirty houses were inundated. These conditions highlight the urgent need for drainage normalization and capacity enhancement to better accommodate runoff and prevent recurrent inundation during the rainy season.

Figure 2. Ibrahim Alley, Rajabasa Induk Subdistrict

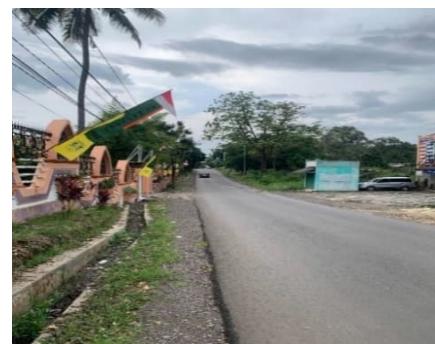
2. **Gang Toyib** (Rajabasa Induk Subdistrict): Toyib Alley, also situated in Rajabasa Induk Subdistrict, experiences similar hydrological challenges. The drainage channels are small and poorly maintained, which prevents efficient runoff discharge. As a result, water frequently accumulates on the streets and in residential yards even during moderate rainfall. Flooding in this area has become a recurring issue during every rainy season. Drainage improvement through widening, dredging, and regular maintenance is necessary to ensure smoother water flow and reduce the frequency of flooding.

Figure 3. Toyib Alley, Rajabasa Induk Subdistrict

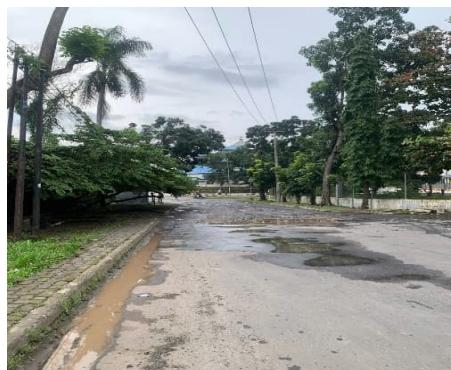
3. **Gang Haji Ismail** (Rajabasa Nyunai Subdistrict): Haji Ismail Alley in Rajabasa Nyunai Subdistrict is among the most flood-prone zones in the Rajabasa area. The site has drawn attention from local authorities, including a visit by the Acting Governor of Lampung, to evaluate river flow conditions and prioritize drainage improvements. The drainage system here is shallow and frequently obstructed by waste and sediment, leading to water overflow during heavy rain. Flooding in this area often disrupts residents' mobility and damages household property. Proper drainage rehabilitation, coupled with increased community awareness of waste management, is crucial to reduce flood impacts..

Figure 4. Haji Ismail Alley, Rajabasa Nyunai Subdistrict

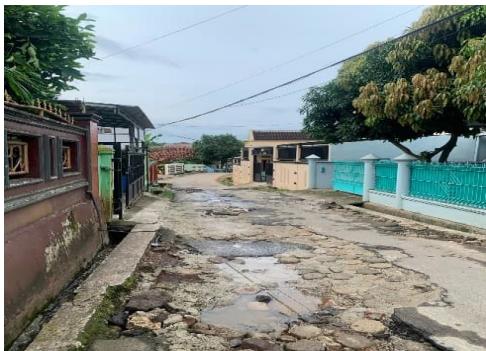
4. **Gang Marga Anak Tuha** (Rajabasa Raya Subdistrict): Marga Anak Tuha Alley, located in Rajabasa Raya Subdistrict, is identified as a high-risk flood zone. The primary causes include narrow drainage channels and sediment buildup, which reduce water discharge capacity. Flooding in this area has previously inundated dozens of

houses and boarding houses, with water levels reaching several tens of centimeters. Such events have damaged furniture, interrupted daily activities, and affected local livelihoods. Mitigation efforts should focus on drainage normalization, sediment removal, and the development of infiltration wells to manage runoff effectively.

Figure 5. Marga Anak Tuha Alley, Rajabasa Raya Subdistrict

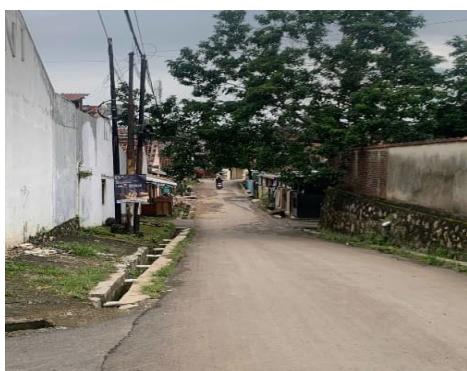
5. **Gang Nunyai** (Rajabasa Subdistrict): Nunyai Alley in the Rajabasa Nunyai Subdistrict is classified as a highly flood-prone area due to inadequate drainage infrastructure and unfavorable topographical conditions. The drainage system in this area is shallow, narrow, and frequently clogged with sediment and household waste, which significantly hinders the proper flow of stormwater during periods of heavy rainfall. The relatively flat terrain further exacerbates water accumulation, leading to recurrent flooding that often lasts for hours or even days. These prolonged inundations disrupt residents' daily activities, damage household belongings, and create potential health risks due to stagnant water and poor sanitation

Figure 6. Nyunyai Alley, Rajabasa Subdistrict

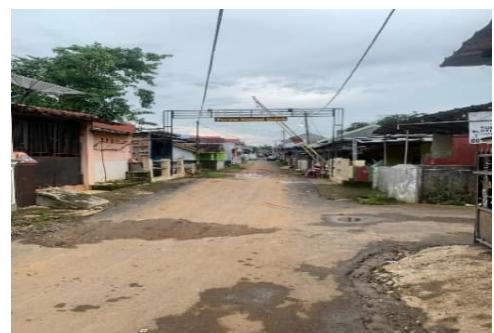
6. **Gang Gelora Persada** (Rajabasa Raya Subdistrict): Gelora Persada Alley, located in Rajabasa Raya Subdistrict, is categorized as a critically flood-prone area. The drainage infrastructure is inadequate, with small channels frequently filled with sediment, and the flat terrain prevents rapid water discharge. During high-intensity rainfall, floodwaters quickly submerge the streets and nearby residences, sometimes cutting off road access. The area urgently requires comprehensive drainage normalization and expansion, as well as the installation of infiltration systems to increase soil absorption and mitigate severe flooding events.

Figure 7. Gelora Persada Alley, Rajabasa Subdistrict
